Understanding the Impact of Vapor Drive

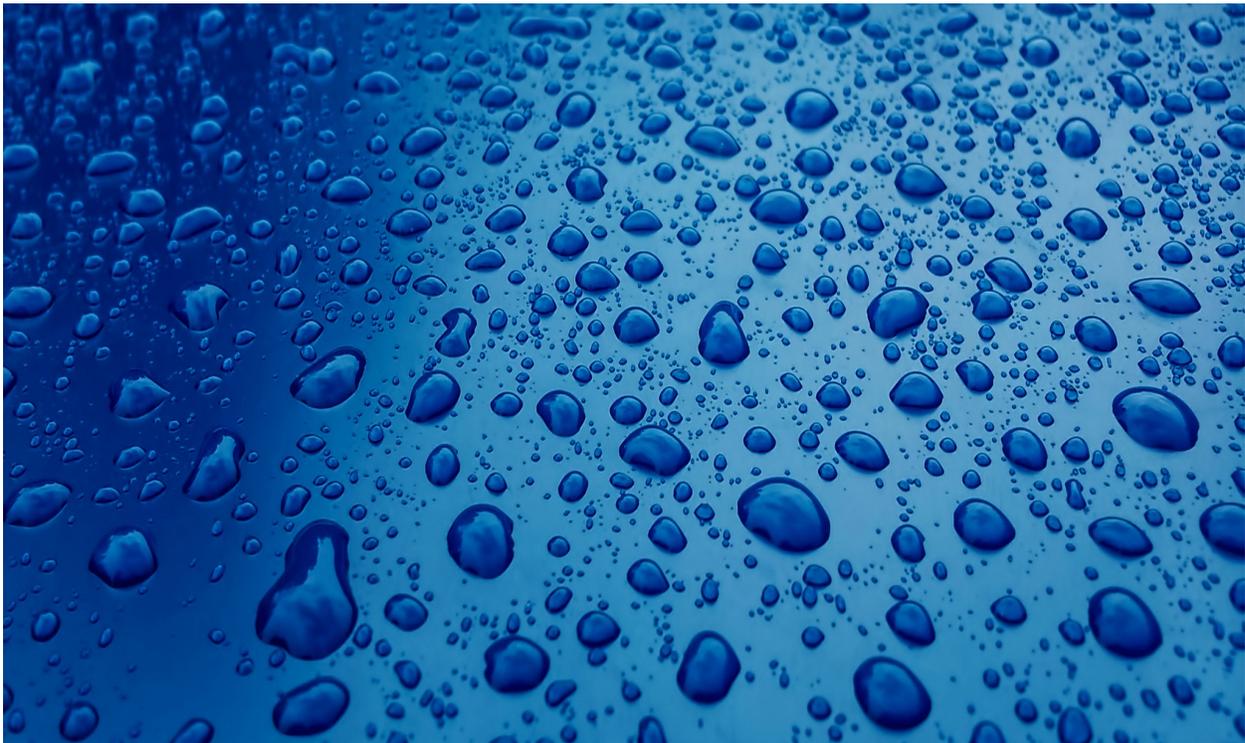
Condensation on a smooth surface, courtesy Brett Jordan

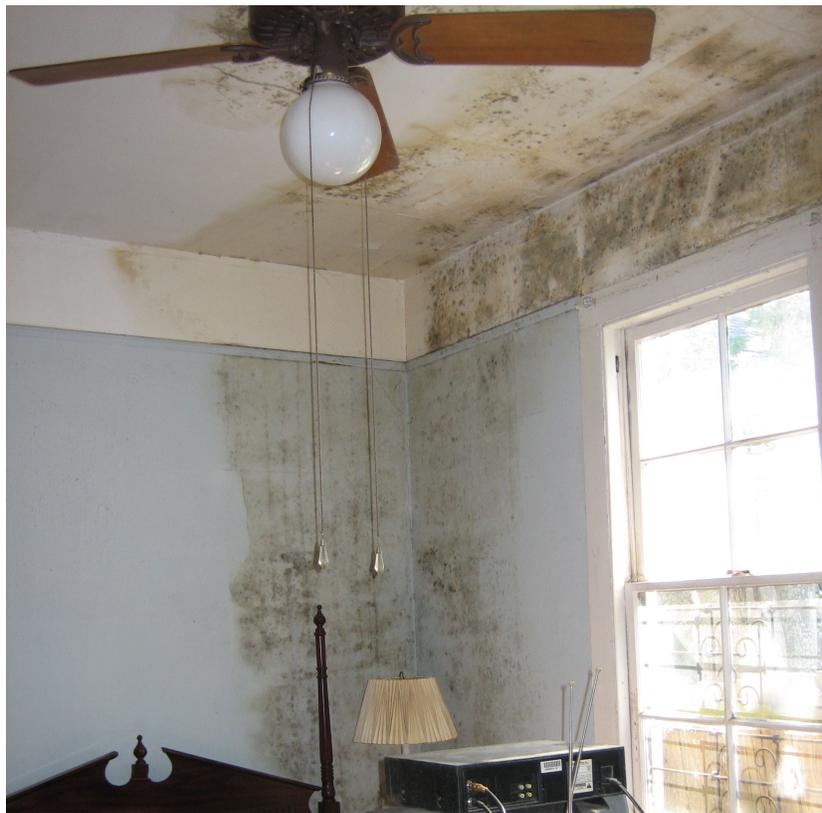
Damaged Caused by Moisture Entrapment, courtesy Infrogmat of New Orleans

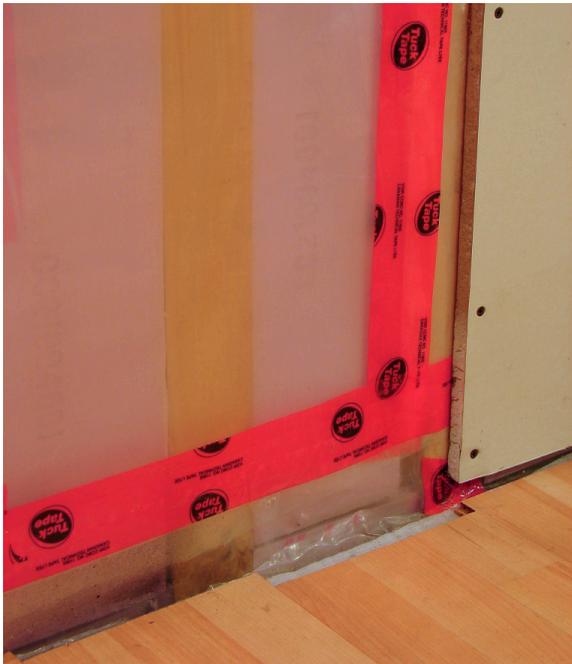
*6 mil Polyethylene plastic sheet as vapor barrier,
courtesy Wikimedia user P199*

A vapor retarder can be made of a variety of materials such as pre-cut fiberglass, plastic or a foil sheet – anything to fill the gaps.

“Vapor drive will be stopped by an impermeable layer,” Burgess said.

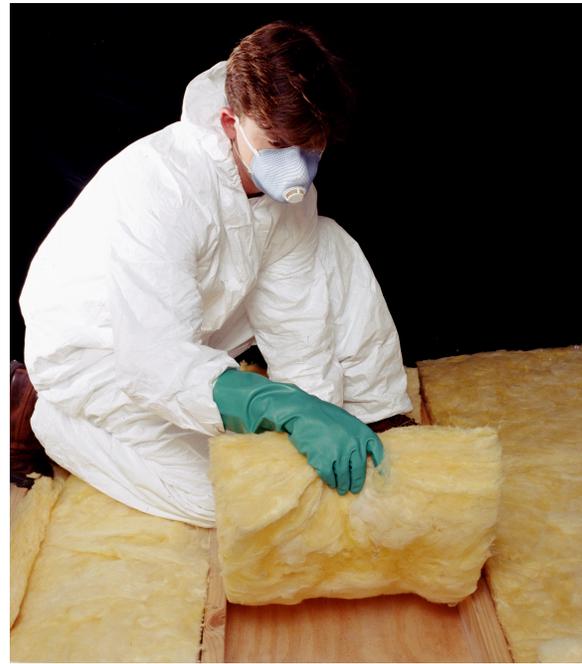
Fiberglass batt insulation, courtesy CSIRO

“The repair was to take out the Kraft paper, dry everything up, and go in with fiberglass batt insulation,” Burgess continued “You need to fill the entire cavity with insulation so there isn’t any air. You need to have what’s called a ‘vapor retarder.’”

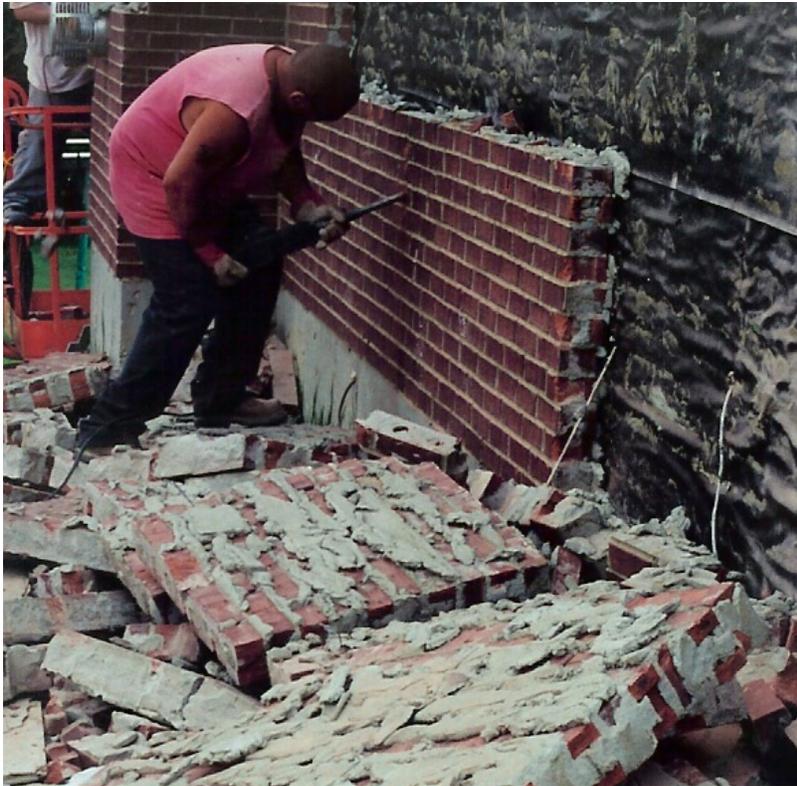
Zaring Homes demolition process, courtesy Green Building Advisor

In the Zaring case, the builders failed to consider the impact of heating and cooling, and the air space behind the brick veneer, resulting in extensive mold and rot.

In the end, the veneer, sheathing, insulation and drywall had to be demolished and replaced. In this case, the Celotex fiberboard apparently acted as a perfect permeable membrane. The condensation occurred after the sun had shined on the brick veneer.
